# Diagnosis report of 2021 OPEL INSIGNIA Edition

# Preparation and repair report of 2021 OPEL INSIGNIA Edition

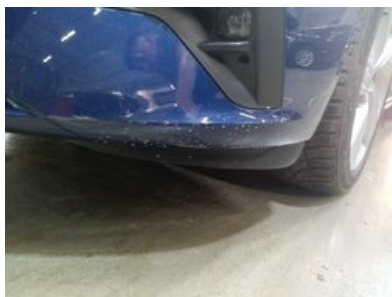
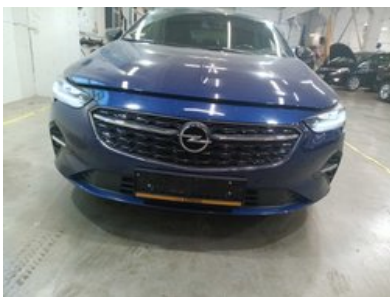
### ✔ 1. Front: Front Bumper - Condition and Alignment

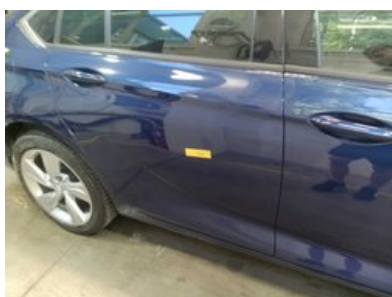
### ✔ 3. Side: Left and Right Side - Visual Damage and Scratches

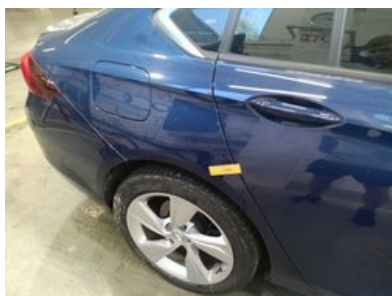
### ✔ 4. Side: Left and Right Side - Visual Damage and Scratches

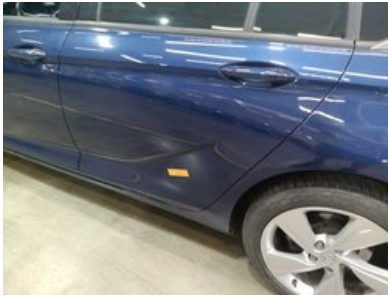
✓ **5. Side:** Left and Right Side - Visual Damage and Scratches

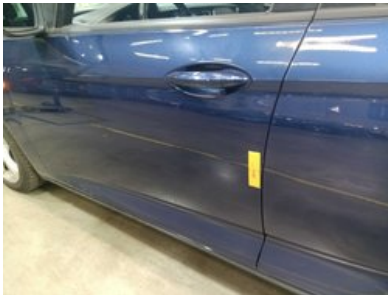
✓ **6. Side:** Left and Right Side - Visual Damage and Scratches

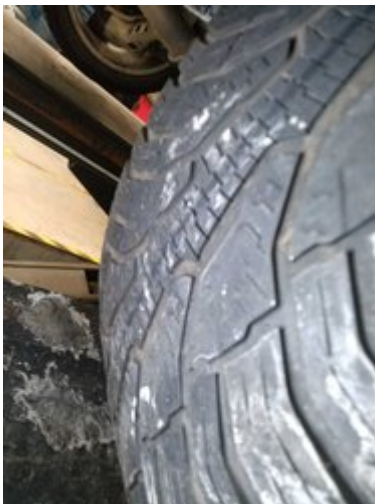
✓ **2. OTHER:** Change Tires
