# Diagnosis report of 2014 MITSUBISHI OUTLANDER Executiv

Diagnosis report of

2014 MITSUBISHI OUTLANDER Executiv

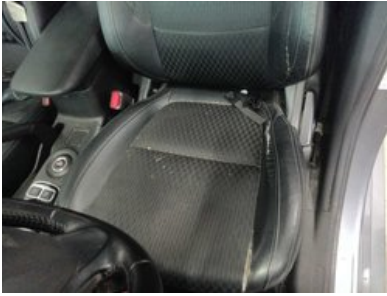
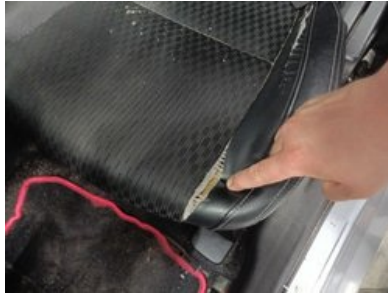
### ✓ 1. Seats: All Seats - Condition

- ✓ 1. Sew Front Seat
- ✓ 2. Change Sun Visor

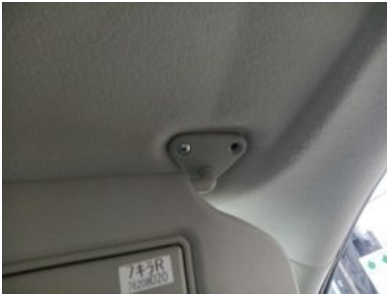
### ✓ 2. Front: Sun Visors - Operation and Condition

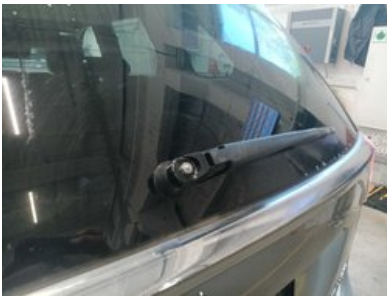
### ✓ 1. Other: Audible Signs (Loose Parts, Rattling, Etc.)

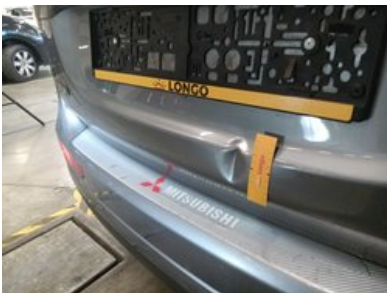
### ✓ 2. Rear: Trunk - Visual Damage

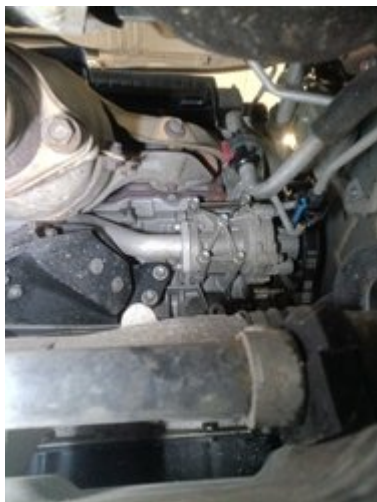
### ✓ 1. ENGINE: Engine Condition

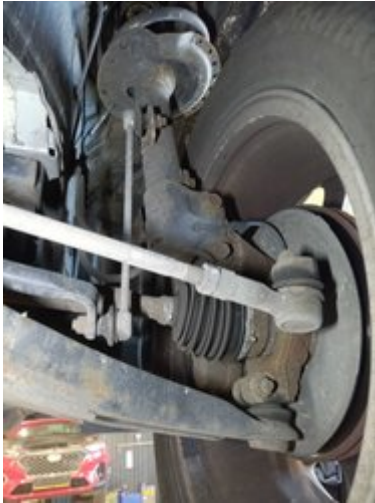
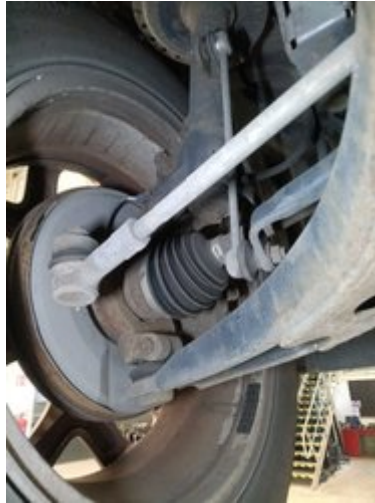
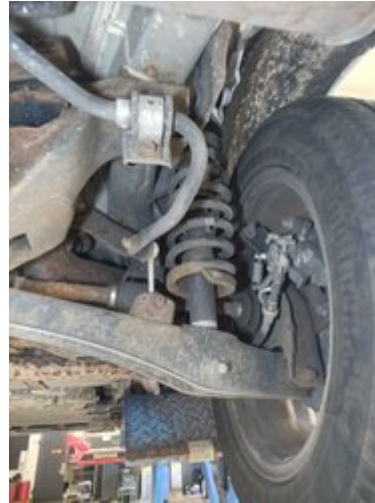
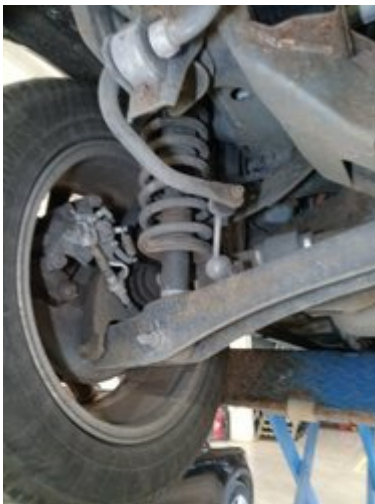
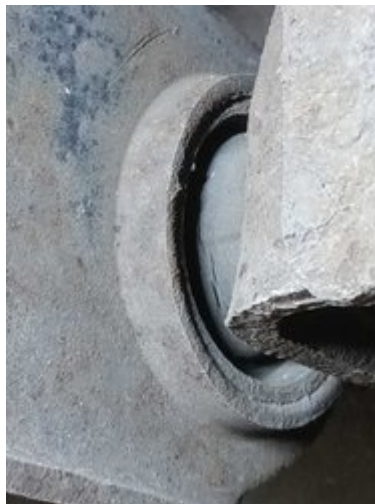
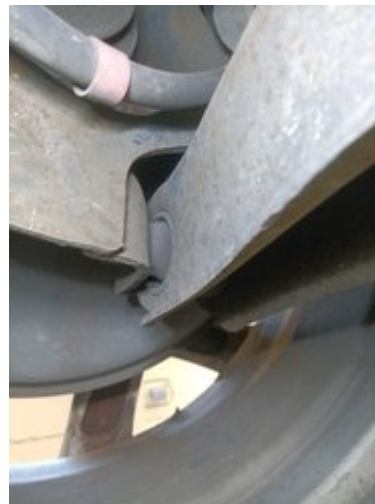
✓ **2. SUSPENSION:** Suspension Condition

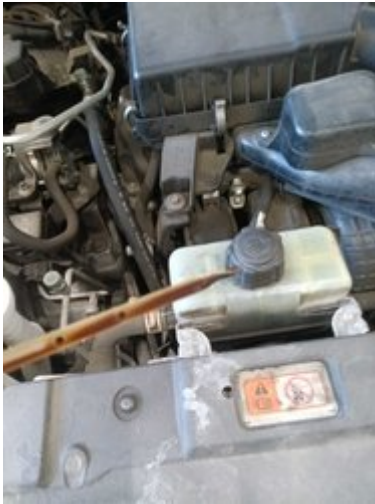
✓ **3. OTHER:** Engine Oil & Filter Change

- ✓ 1. Front Brakes and Pads
- ✓ 2. Engine Oil & Filter Change

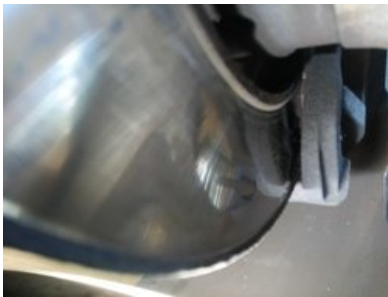
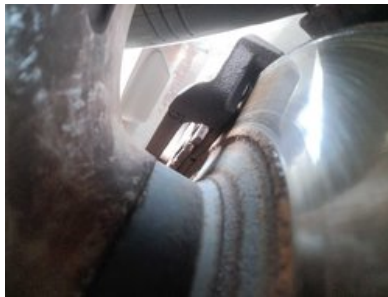
✓ **4. BRAKES:** Brakes Condition

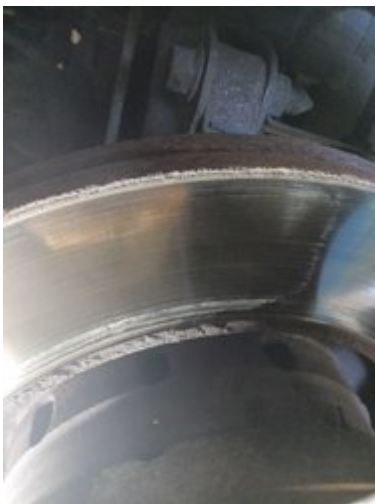
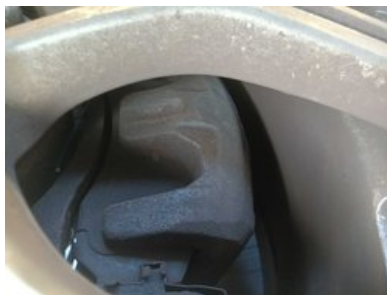
✓ **5. BRAKES:** Front Brakes and Pads
