# Diagnosis report of 2018 TOYOTA AURIS

## Summary of diagnosed issues

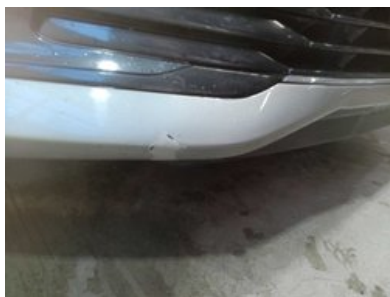
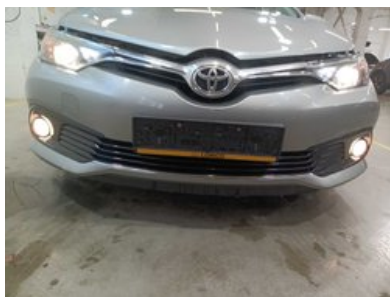
### ✔ 1. Front: Front Bumper - Condition and Alignment

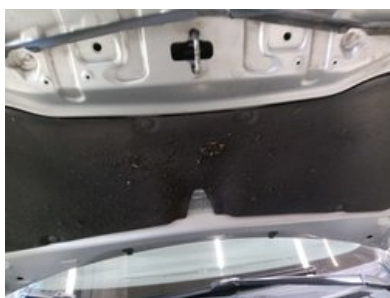
### ✔ 2. Front: Hood Sound Insulation - Condition

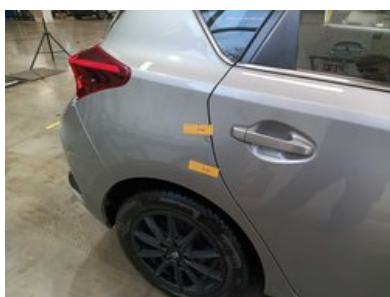
### ✔ 3. Side: Left and Right Side - Visual Damage and Scratches

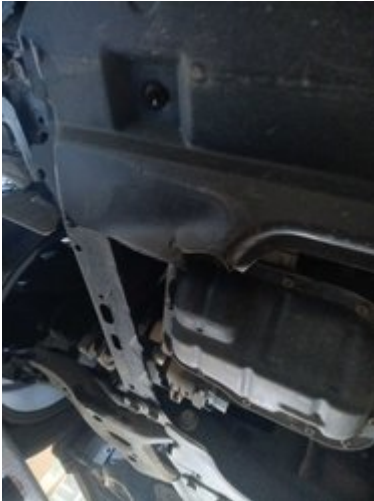
### ✓ 1. BODY - FRONT SECTION: Damaged Engine Cover
