# Diagnosis report of 2019 TOYOTA C-HR Active

# Preparation and repair report of 2019 TOYOTA C-HR Active

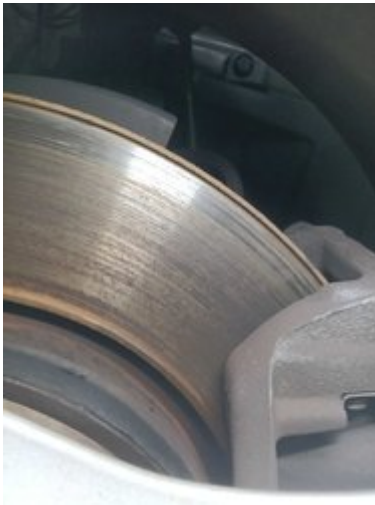
✓ **1. OTHER:** Engine Oil & Filter Change

✓ **2. BRAKES:** Front Brake Discs Both

- ✓ 1. Engine Oil & Filter Change
