Diagnosis report of 2019 PEUGEOT 2008 Allure

Diagnosis details

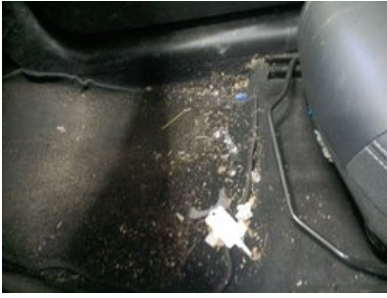
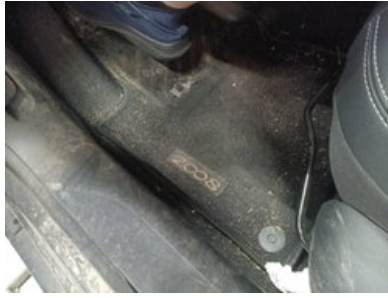
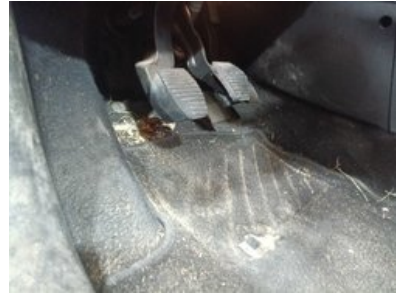
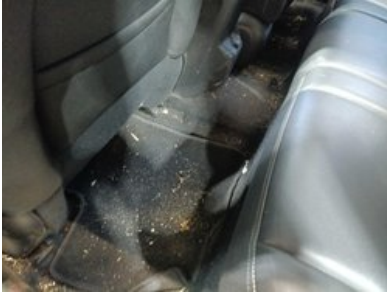
✓ 1. Inside: Additional Cleaning Tasks

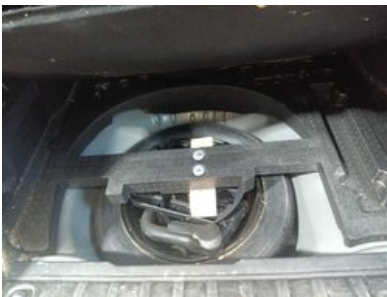
✓ 2. Inside: Trims - Condition

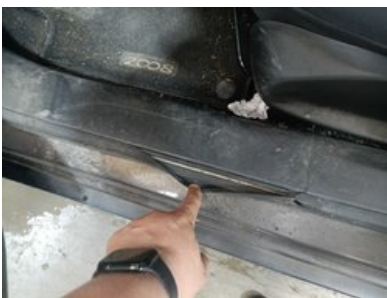
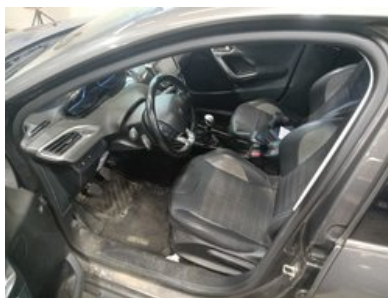
✓ 3. Doors: Door Rubber Seals

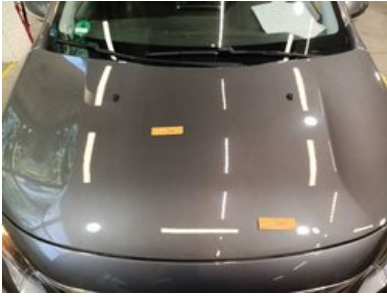
✔ **1. Front:** Hood - Visual Damage

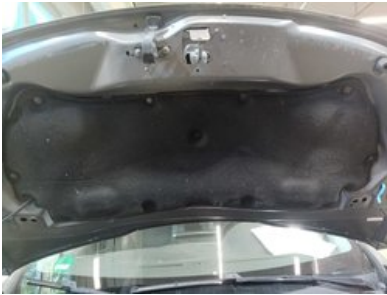
✔ **2. Front:** Hood Sound Insulation - Condition

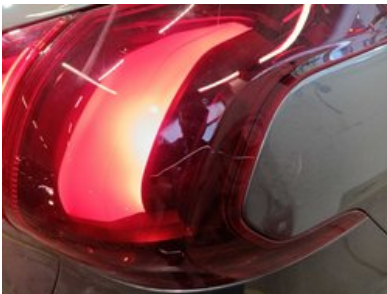
✔ **3. Other:** Additional Polishing Tasks

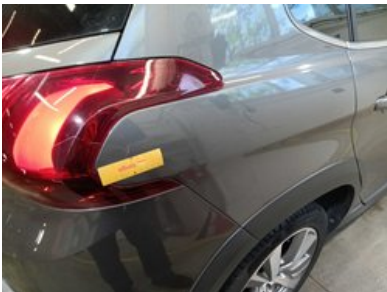
✔ **4. Side:** Left and Right Side - Visual Damage and Scratches

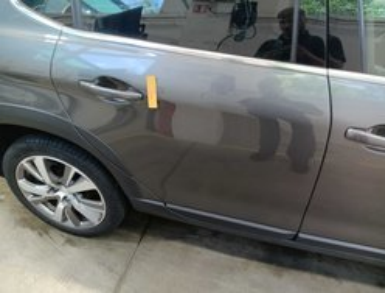
✓ **5. Side:** Left and Right Side - Visual Damage and Scratches

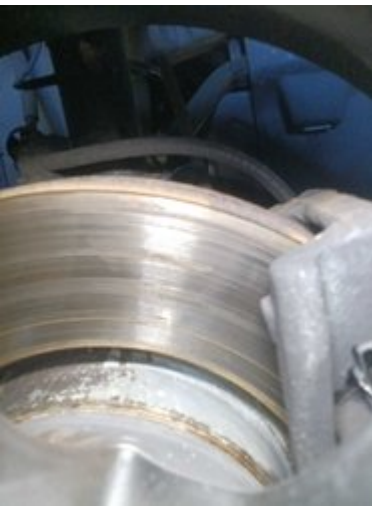
✓ **1. BRAKES:** Front Brake Discs Both

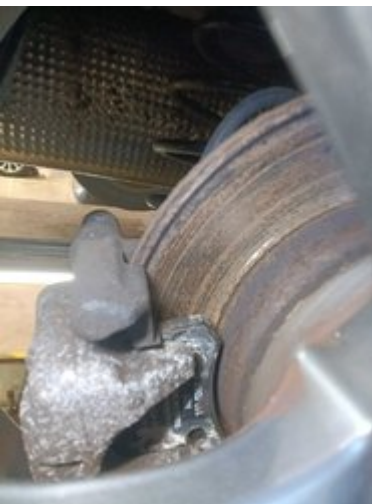
✓ **2. BRAKES:** Rear Brake Disc (Both)

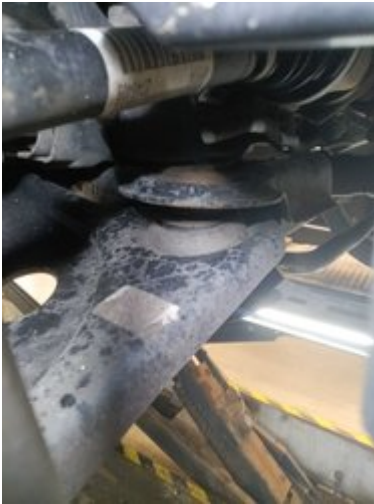
✔ **5. SUSPENSION:** Suspension Lower Arm Both

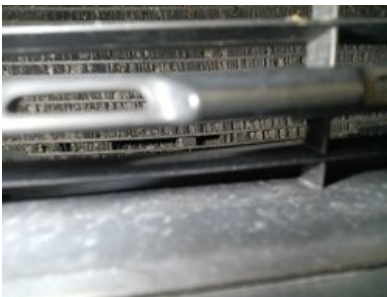
✔ **6. AIR CONDITIONING AND HEATING:** Condenser
