# Diagnosis report of 2020 NISSAN QASHQAI Business Edition

Diagnosis report of

2020 NISSAN QASHQAI Business Edition

Diagnosis details

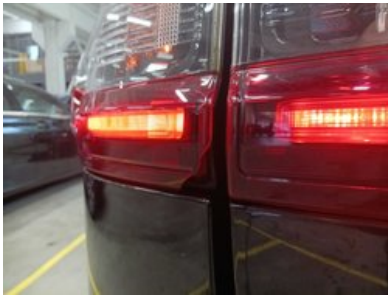
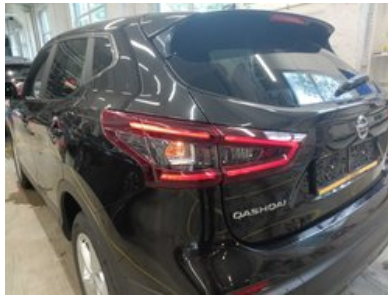
- ✓ **1. Lights:** Rear Lights (Brake, Fog, Indicator) - Basic Functioning, Damage, and Color

- ✓ 1. Change Rear Lights

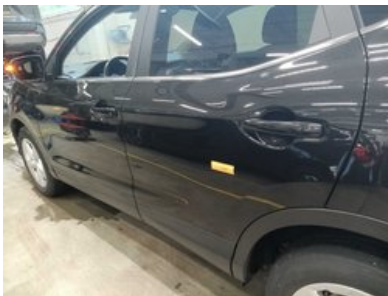
- ✓ **2. Side:** Left and Right Side - Visual Damage and Scratches

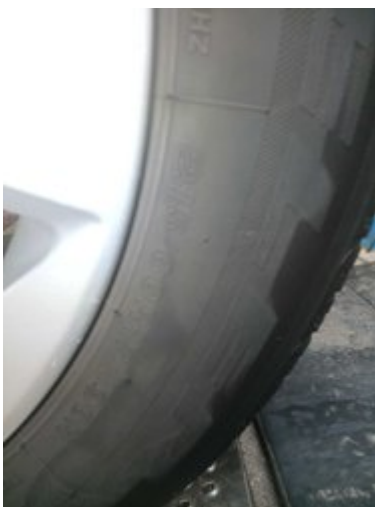
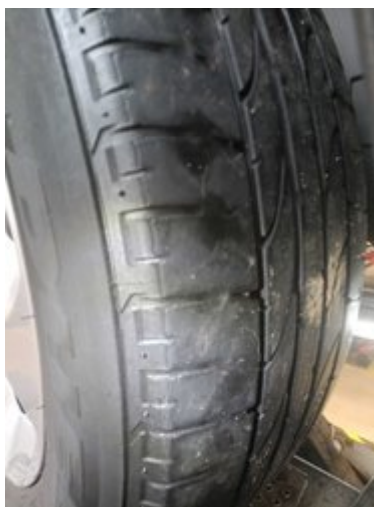
- ✓ **1. OTHER:** Engine Oil & Filter Change
- ✓ **2. OTHER:** Coolant Refill
- ✓ **3. OTHER:** Charge Battery
- ✓ **4. OTHER:** Change Tires

- ✓ 1. Coolant Refill
- ✓ 2. Engine Oil & Filter Change
- ✓ 3. Change Tires
- ✓ 4. Charge Battery
