# Diagnosis report of 2022 PEUGEOT 3008 GT

Mileage on completion date: 191 150 km

Checked by Longo Shared Service certified diagnostics team: Mindaugas G., Arnas S.

# Preparation and repair report of 2022 PEUGEOT 3008 GT

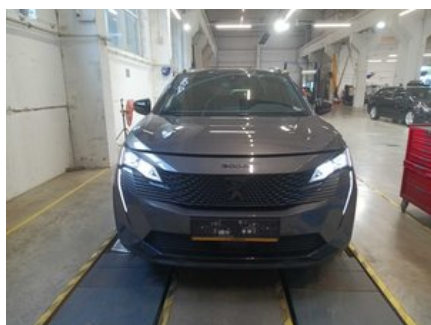
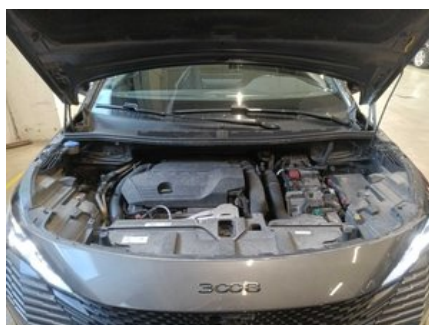
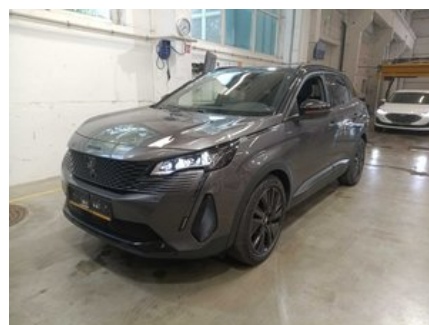
## Diagnosis process

| Built-in Systems Interface(Bsi) | | 9 | Enter |
| U015F Fault: No Communication With: Remote2-B20 | Intermittent | | |
| U015B Fault In The Linking Of The Immobiliser By The Engine Management ECU | Intermittent | | |
| U1805 Lack Of Collaboration Between The Status Of The Engine Starting Switch And The Status Of The Built-in Systems Interface Internal Combustion Engine Starting Authorisation Cluster | Intermittent | | |
| U1959 Fault Event Not Stored In The Fault Log | Permanent | | |
| U015F Communication Fault With The Built-in Systems Interface: No Communication | Intermittent | | |
| P156F Auxiliary Drive Belt: Break Immminent | Permanent | | |

- ✓ 1. Auxiliary Drive Belt
- ✓ 2. Engine Oil & Filter Change

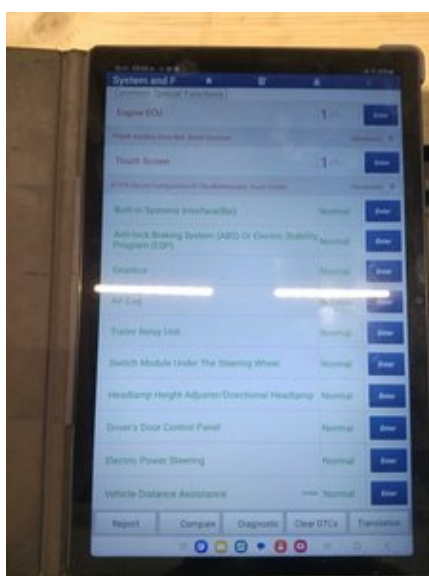
| Built-in Systems Interface(Bsi) | | 9 | Enter |
|---|---|---|---|
| Engine ECU | 2 | Enter | |

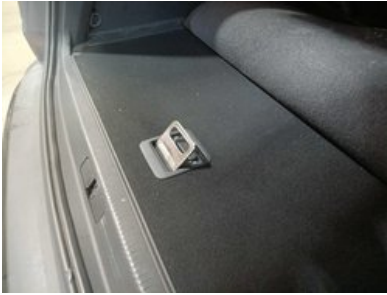
✔ **1. Inside:** Carpets - Condition

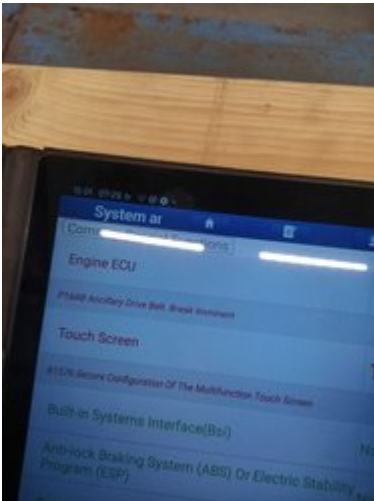
✓ **1. OTHER:** Engine Oil & Filter Change

✓ **2. ENGINE:** Auxiliary Drive Belt

- 1. Oil Filter (OE673)
- 2. Engine Oil 4.3L
- 3. Oil Pan Gasket (834.823)
