Diagnosis report of
2015 BMW 750 High Executive

Preparation and repair report of
2015 BMW 750 High Executive

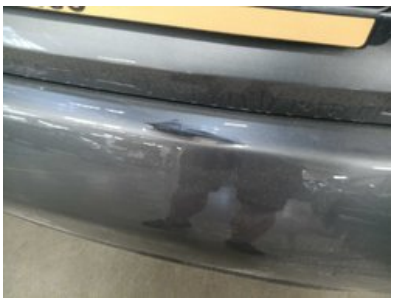
1. Front: Front Bumper - Condition and Alignment

- 1. Paint Rear Bumper
- 2. Paint Front Bumper
- 3. Paint Wheel (4 Pieces)
- 4. Paint Brake Calipers
