Diagnosis report of
2016 VOLVO XC90 Inscription

Diagnosis details

Summary of diagnosed issues

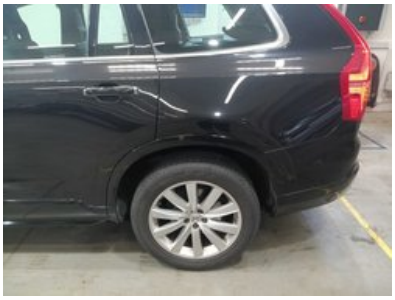
Exterior

1. Front: Windscreen Integrity - Free from MOT-Excluding Damage

2. Side: Left and Right Side - Visual Damage and Scratches

3. Side: Left and Right Side - Visual Damage and Scratches

- 1. Windshield Replacement
