Diagnosis report of
2020 VOLKSWAGEN GOLF 8 Life

Diagnosis details

Preparation and repair report of
2020 VOLKSWAGEN GOLF 8 Life

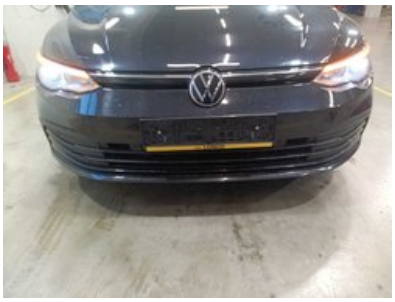
2. Other: Additional Polishing Tasks
