Diagnosis report of
2015 KIA SPORTAGE BusinessLine

Preparation and repair report of
2015 KIA SPORTAGE BusinessLine

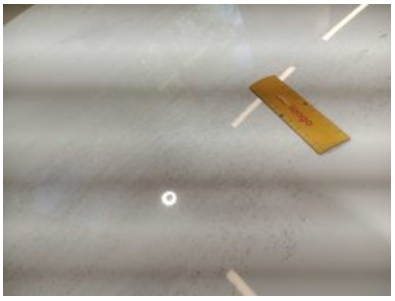
1. Side: Exterior Mirrors - Mirror Integrity and Car Attachment

- 1. Change All Exterior Mirrors
