Diagnosis report of
2015 OPEL MERIVA Cosmo

Summary of diagnosed issues

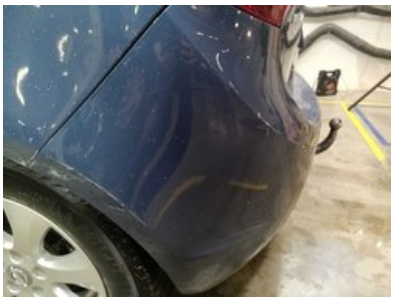
1. Rear: Rear Bumper - Condition and Alignment

2. Other: Roof - Visual Damage (e.g., Hail Damage)

3. Other: Additional Polishing Tasks

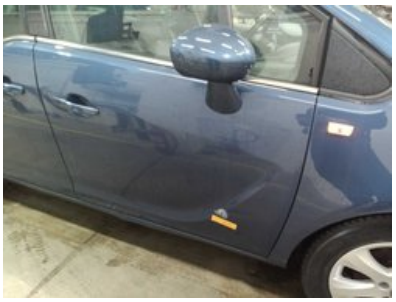
4. Side: Left and Right Side - Visual Damage and Scratches

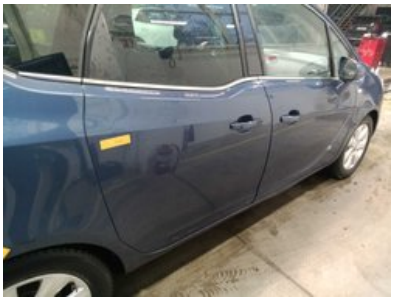
5. Side: Left and Right Side - Visual Damage and Scratches

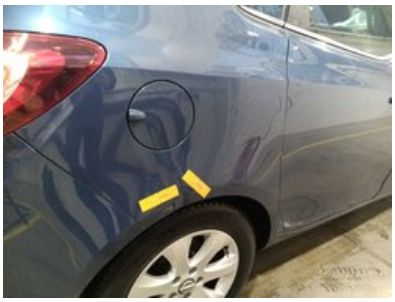
6. Side: Left and Right Side - Visual Damage and Scratches
