Diagnosis report of
2020 SKODA KAROQ Sportline Business

Diagnosis details

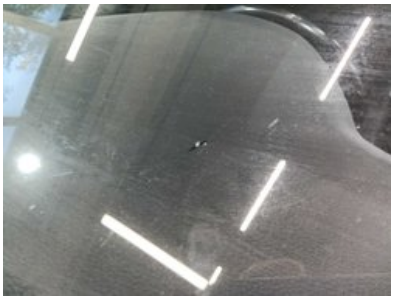
1. Front: Front Bumper - Condition and Alignment

2. Front: Windscreen Integrity - Free from MOT-Excluding Damage

3. Rear: Rear Bumper - Condition and Alignment

- 1. Windshield Repair

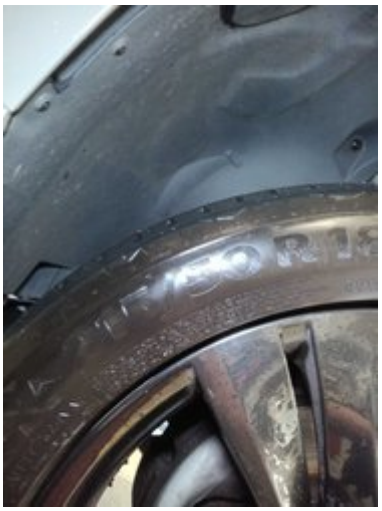
1. OTHER: Engine Oil & Filter Change

2. OTHER: Change Tires

3. SUSPENSION: Suspension Lower Arm Both

- 1. Suspension Lower Arm (Both)
- 2. Engine Oil & Filter Change
- 3. Change Tires

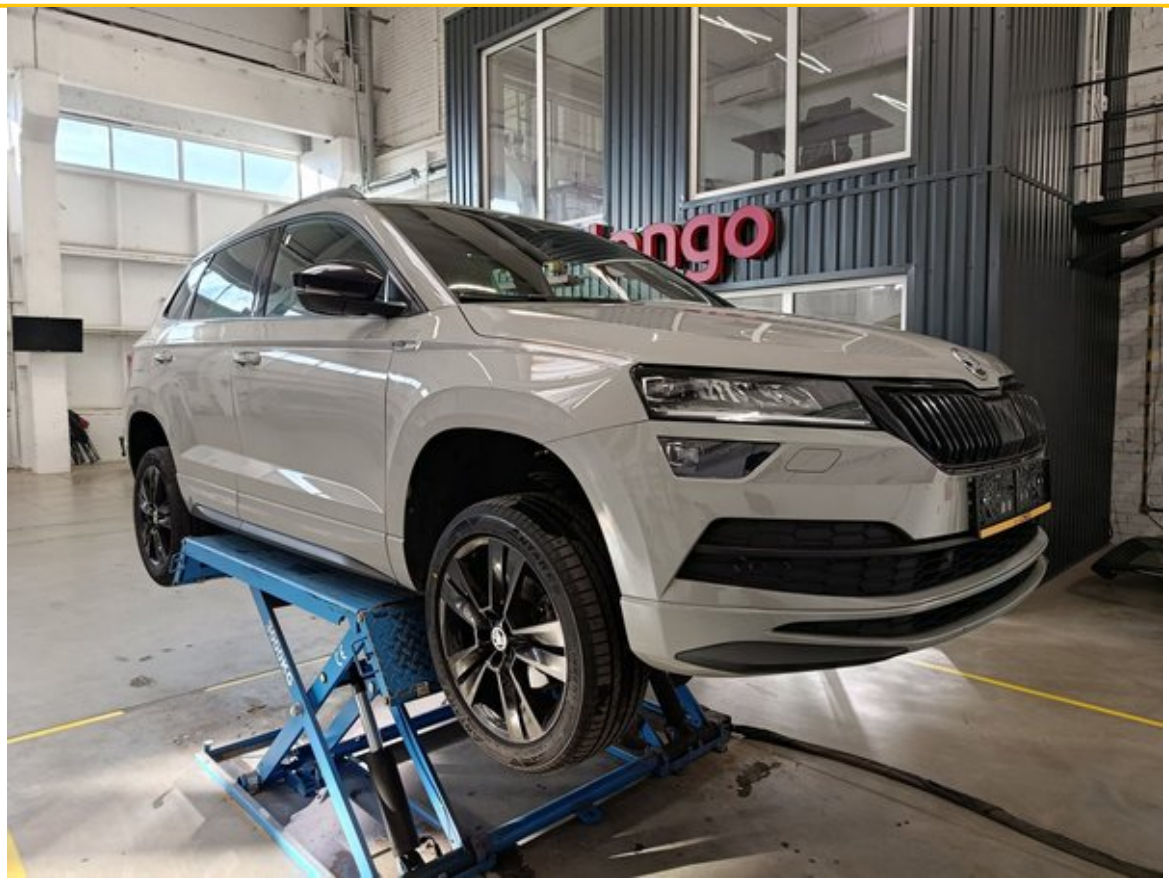
ANTARES

1. Oil Filter (OP616/3)
2. Control Arm Bush (1006100036)
3. Quartz Ineo Xtra EC6 0W20 208L 4.3L
4. Antares 215/50R18 92V Ingens EV (AT000410)
5. Oil Drain Plug (32912281)
