Diagnosis report of
2022 SKODA OCTAVIA MHEV Business E

Diagnosis details

Preparation and repair report of
2022 SKODA OCTAVIA MHEV Business E

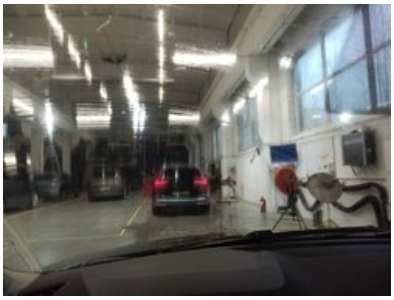
1. Front: Window Wiper Rubber and Handle (Front and Rear) - Condition

- 1. Change Front Wiper (Mechanical)
- 2. EVAP
- 3. Suspension Lower Arm Bushes (Both)
- 4. Engine Oil & Filter Change

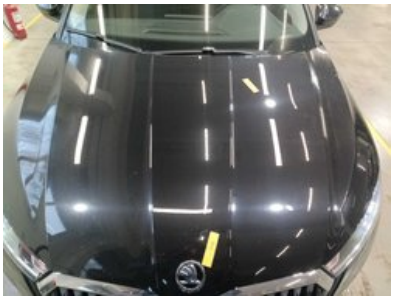
1. Side: Left and Right Side - Visual Damage and Scratches

2. Front: Hood - Visual Damage
