Diagnosis report of
2015 VOLVO V40 Cross Country

Preparation and repair report of
2015 VOLVO V40 Cross Country

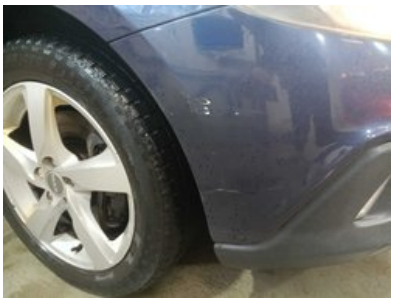
1. Side: Left and Right Side - Visual Damage and Scratches
