Diagnosis report of
2010 OPEL INSIGNIA Sedan

Checked by Longo Shared Service certified diagnostics team: Eimantas A., Arnas S., Mindaugas G., Mantas G.

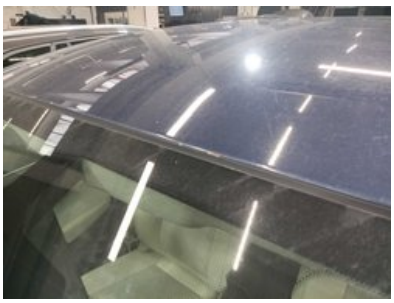
Exterior

1. Side: Wheels - Condition

2. Side: Left and Right Side - Visual Damage and Scratches

3. Side: Left and Right Side - Visual Damage and Scratches

4. Lights: Light Bulbs

5. Lights: Light Bulbs

6. Lights: Front Lights (City, Regular, Full Headlight, Fog, Indicator) - Basic Functioning, Damage, and Color

7. Other: Roof - Visual Damage (e.g., Hail Damage)

- 1. Right Engine Bay Mounting
- 2. Gearbox
- 3. Pipe - Front/Downpipe
- 4. Engine Oil & Filter Change
- 5. Repair Wiring
- 6. Change Bulb for Headlights
- 7. Change Bulb for Rear Fog Lights
- 8. Front Wheel Alignment (Toe)
- 9. Spark Plugs

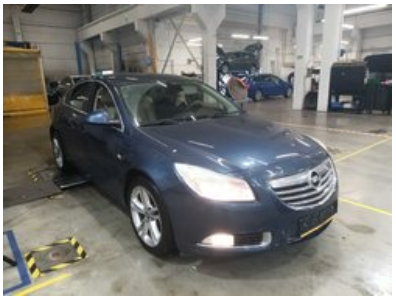
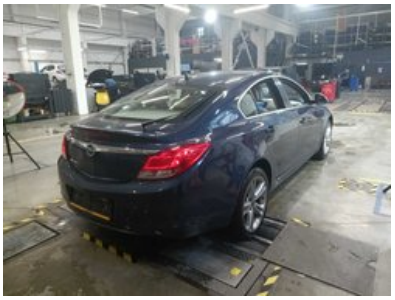
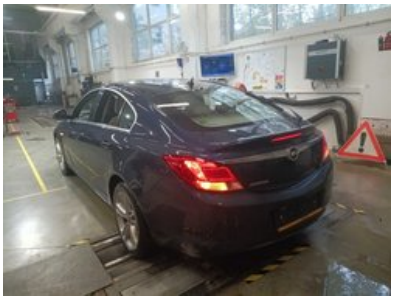
Mechanical

1. OTHER: Repair Wiring

2. OTHER: Engine Oil & Filter Change

3. BRAKES: Rear Brake Disc (Both)

4. EXHAUST SYSTEM: Pipe - Front/Downpipe

5. MANUAL TRANSMISSION: Gearbox

6. ENGINE: Oil Cooler

7. ENGINE: Mounting - Right (of Engine Bay)

8. SUSPENSION: Suspension Lower Arm Bushes Both

9. STEERING: Front Wheel Alignment (Toe)

10. ENGINE MANAGEMENT - IGNITION: Spark Plugs

1. Engine Oil 4.5L
2. Oil Filter (OE648/6)
3. Sealing Plug (8030034)
4. Spark Plug (OE198/T10)
5. Exhaust System Gasket (WALK82114)
6. Exhaust System Gasket (BOS256-119)
7. Engine Mount (6140300030)
8. Manual 6-Speed Gearbox Insignia A 55194293 (KAD14667)
9. Exhaust System Vibration Damper (JMJ55X150P)

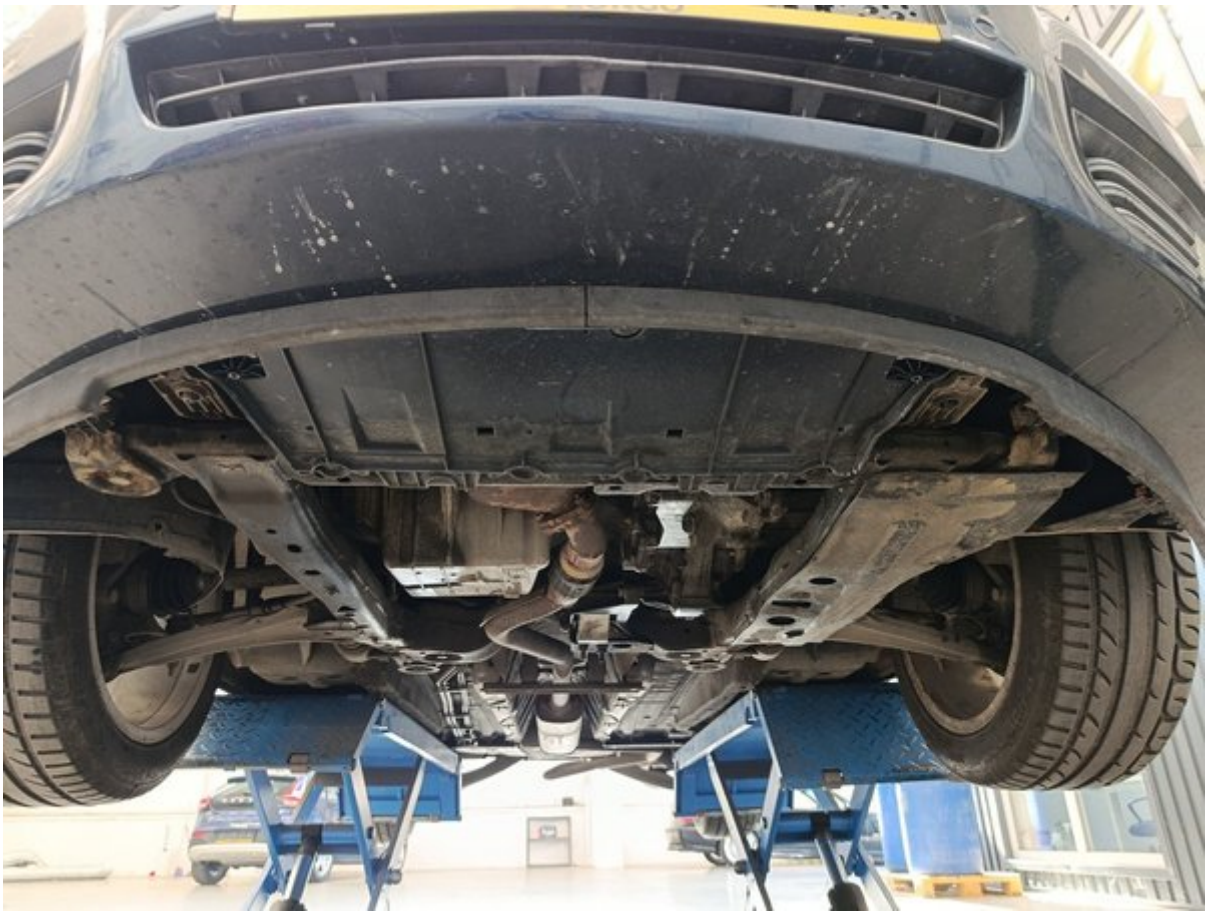
TotalEnergies
Oil:
5W30
Mileage:
243045
Date:
2026.10.08
Oil Filter Change:
Next Oil Change
Mileage:
253045
Date:
2024.10.08
Service Technician Signature:
baltics.totalenergies.com
