# Diagnosis report of 2016 TOYOTA AURIS Business

# Preparation and repair report of 2016 TOYOTA AURIS Business

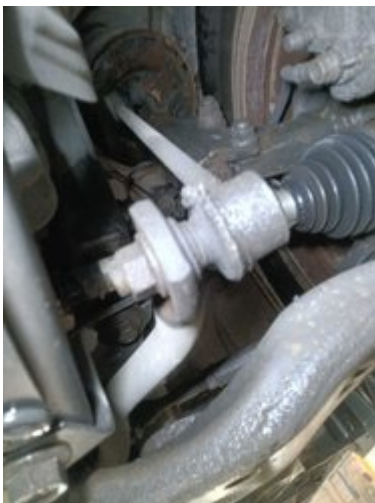
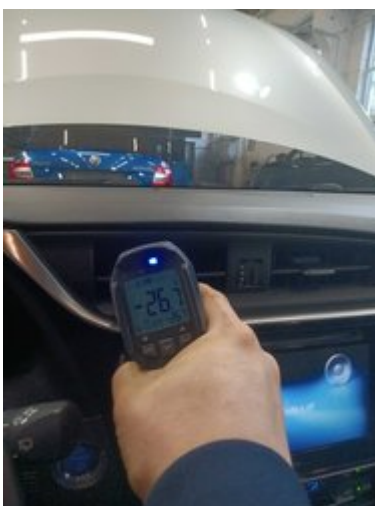
✔ **3. BRAKES:** Front Brake Discs Both

- ✓ 1. System Evacuation/Recharging
- ✓ 2. Front Brake Discs (Both)
- ✓ 3. Anti-Roll Bar Bush - Outer
- ✓ 4. Engine Oil & Filter Change
